WORKER INJURED BY FALLING THROUGH HOLE IN ROOF

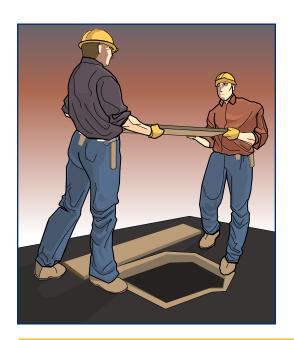
worker suffered serious injuries recently while preparing for a roofing job. He and another worker picked up a large piece of plywood, one worker at either end, in order to remove it from the roof. The workers did not realize the plywood was being used to cover a hole that had been cut in the roof for mechanical services to the building. As they moved the plywood, one worker fell through the hole, approximately 8 metres. He broke both arms and sustained injuries to his head, back and internal organs.

WHSCC investigating officers determined the cause of the accident was **failure to secure and identify the cover over the hole.**

The workers had not been told about the hole in the roof and the plywood being used to cover it, and there was no sign or warning posted.

- Guardrails are the preferred method for protecting workers near floor and roof openings. However, guardrails may not always be practical due to narrow access. In that case, an alternate cover must be installed and marked.
- Use planks, plywood or steel plates for covers. In some cases, pallet-type designs can make covers stronger and less likely to be removed.
- Make covers stand out with bright paint. DANGER!
 OPENING. DO NOT REMOVE. DO NOT LOAD!
- Fasten the cover securely to prevent workers from removing it and falling in the hole.
- Be sure the cover is strong enough to support any load to which it may be subjected (e.g.: the weight of a person walking across it).
